Willamette River Bridges

Bridge Repair Needs

Willamette River Bridges – 20-Year Repair Needs

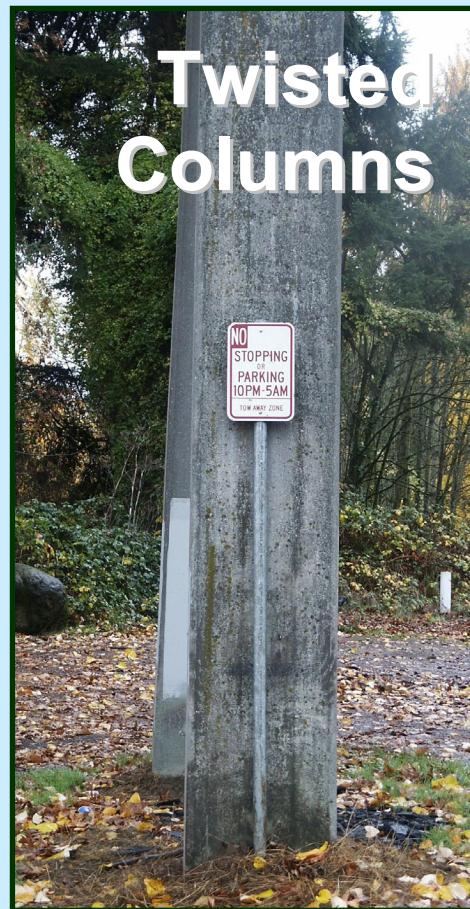
Twisted Columns

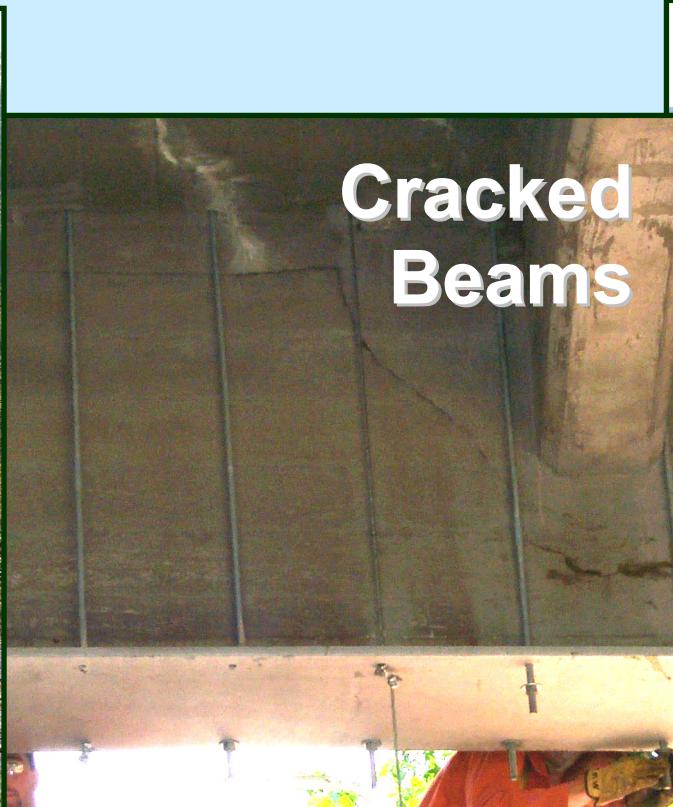
Cracked Beams

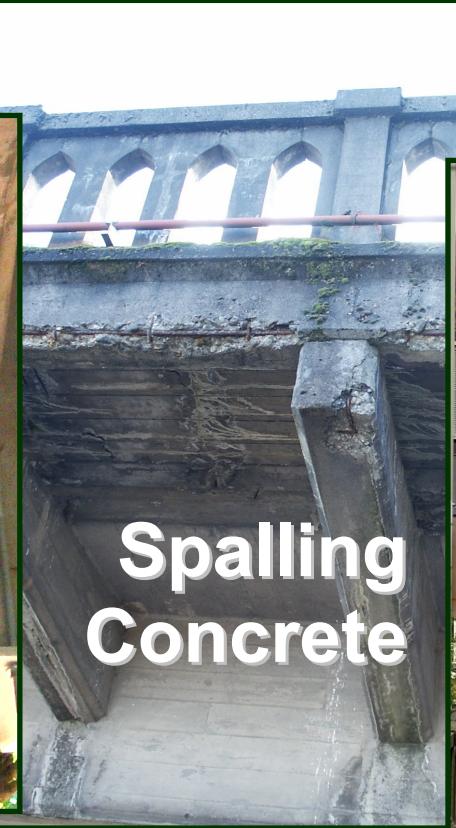
Spalling Concrete

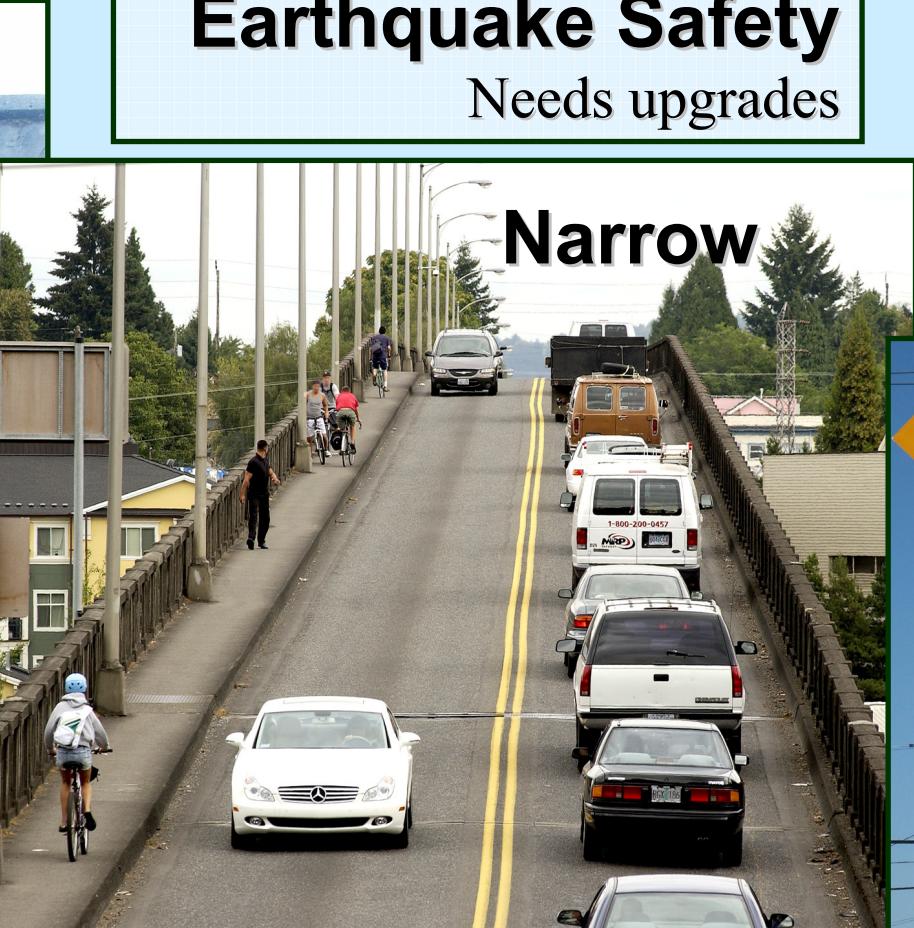
Narrow

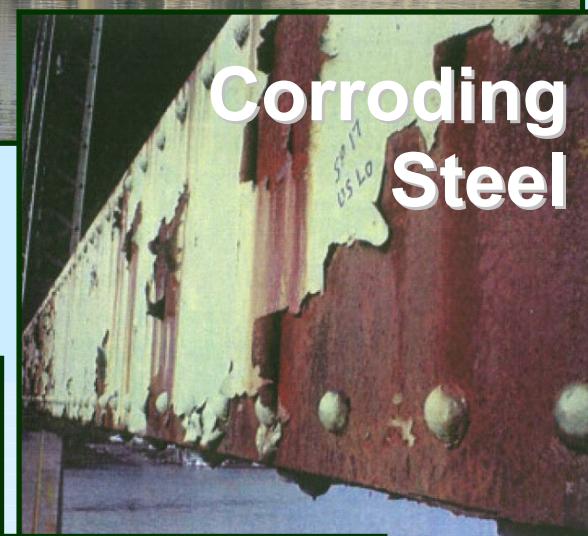
Corroding Steel

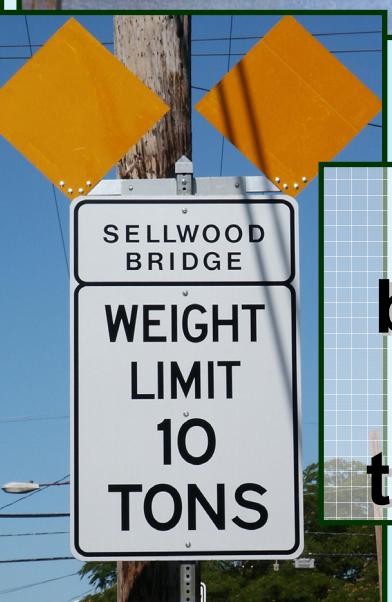
Earthquake Safety
Needs upgrades

No
buses
No
trucks

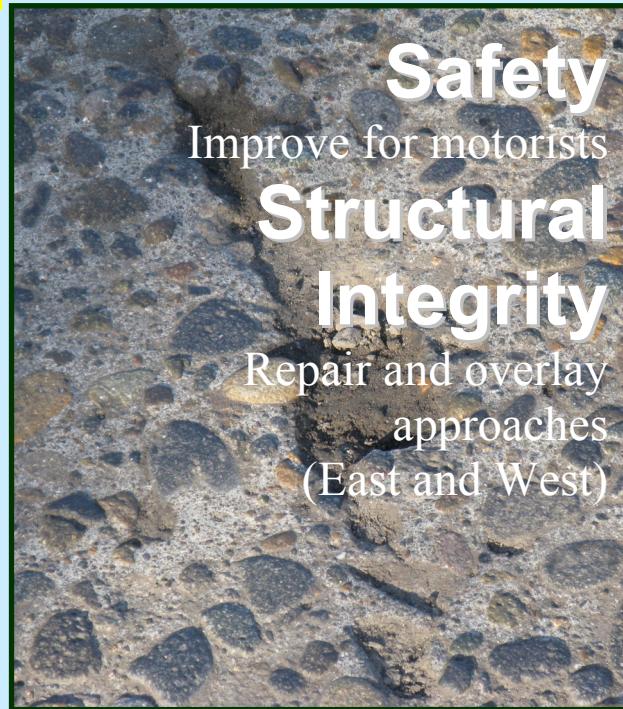
Safety
Improve for motorists
Structural Integrity
Repair and overlay approaches
(East and West)

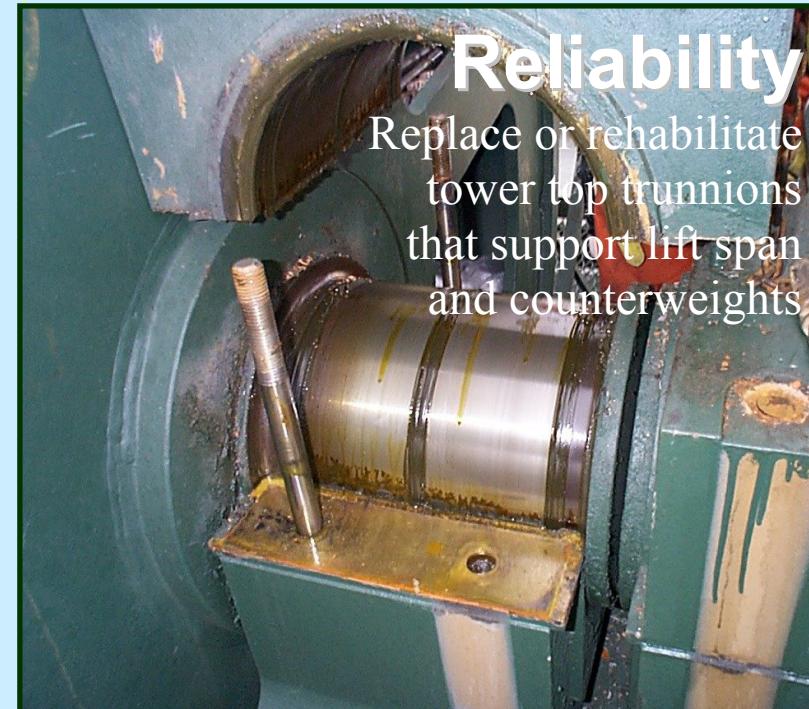
Reliability
Replace or rehabilitate tower top trunnions that support lift span and counterweights

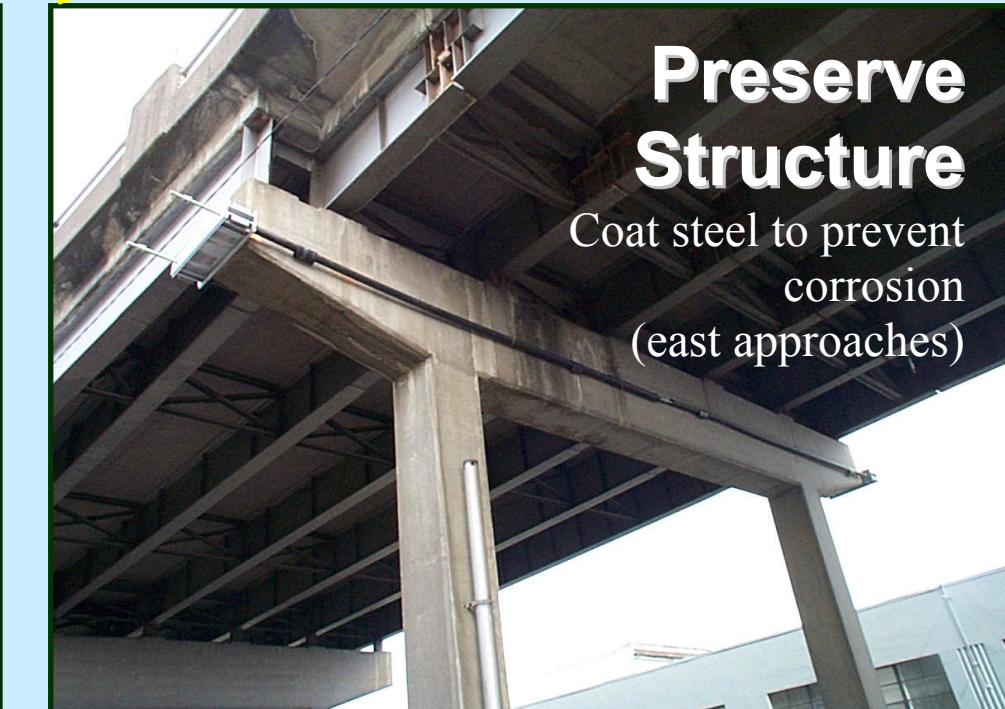
Preserve Structure
Coat steel to prevent corrosion
(east approaches)

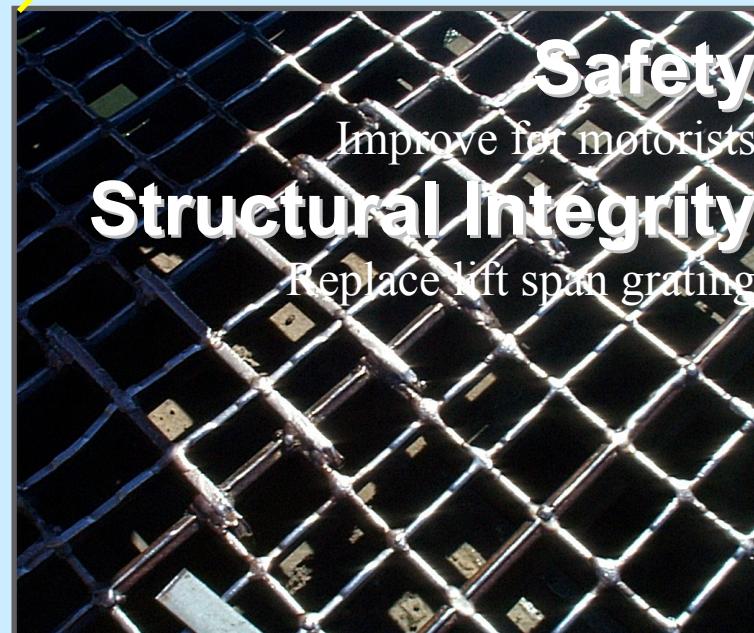
Safety
Improve for motorists

Structural Integrity
Replace lift span grating

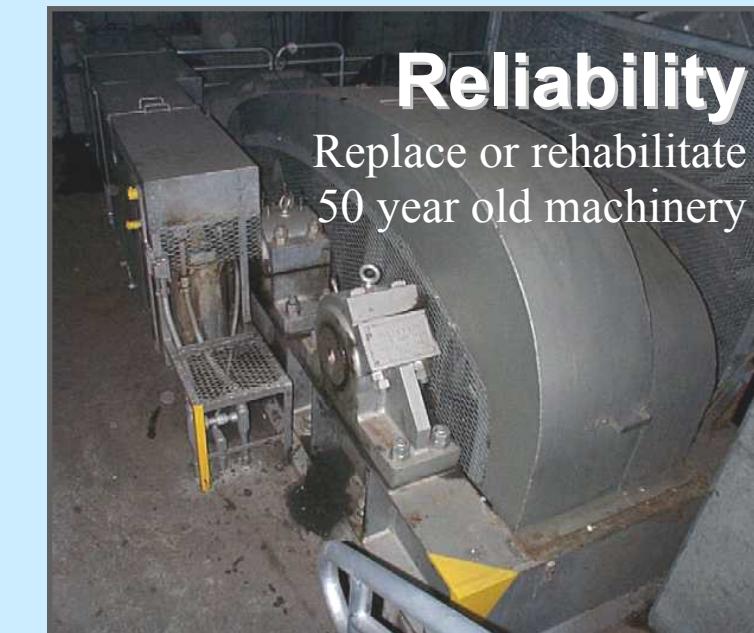
Reliability

Replace or rehabilitate
50 year old machinery

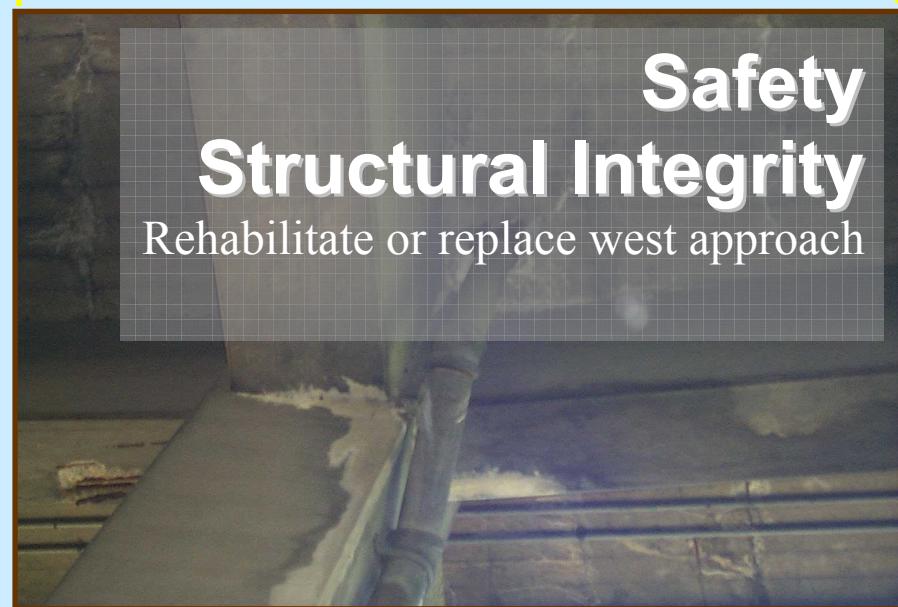
Safety Structural Integrity

Rehabilitate or replace west approach

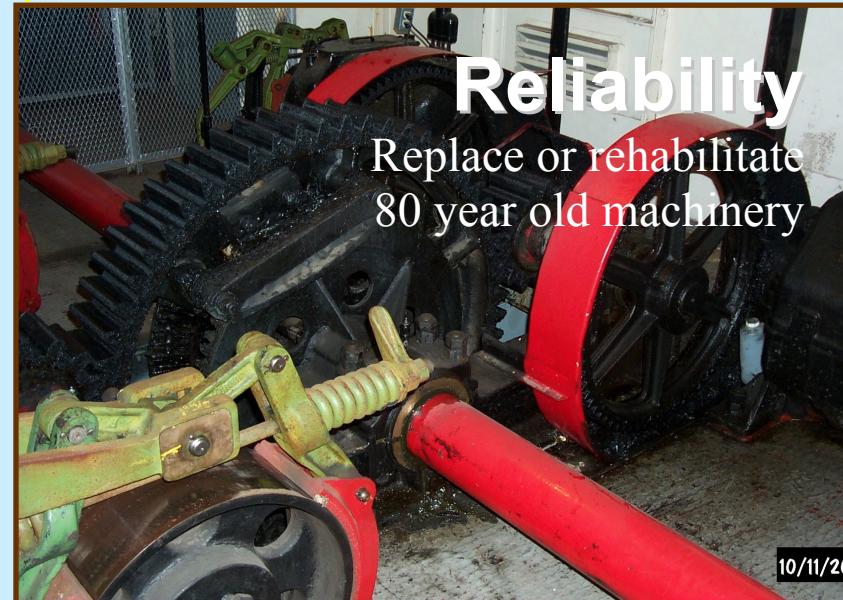
Reliability

Replace or rehabilitate
80 year old machinery

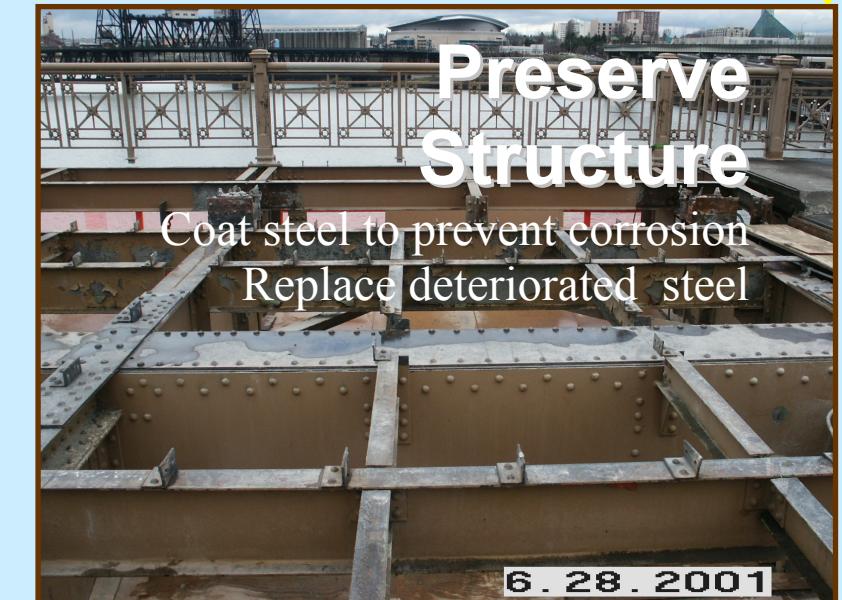
Preserve Structure

Coat steel to prevent corrosion
Replace deteriorated steel

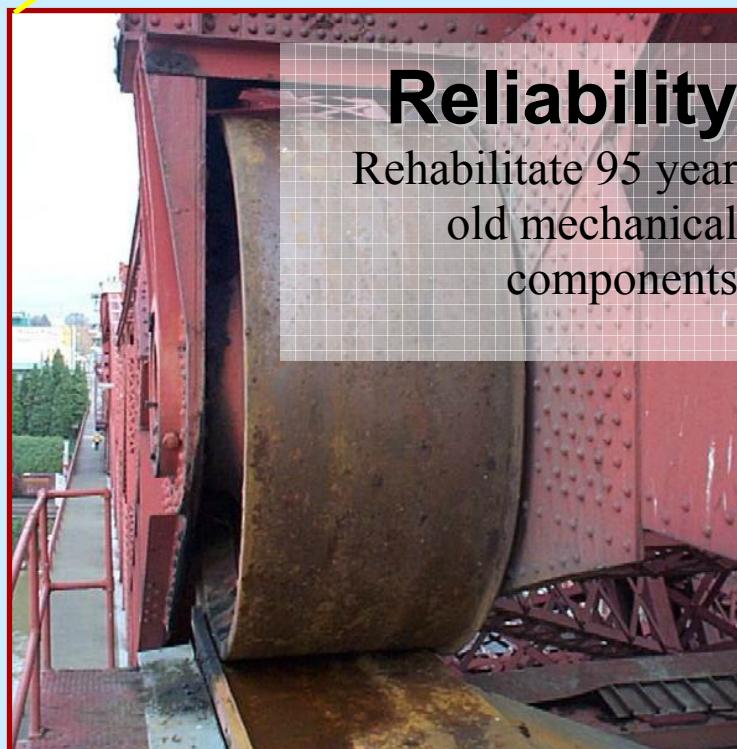
Reliability

Rehabilitate 95 year
old mechanical
components

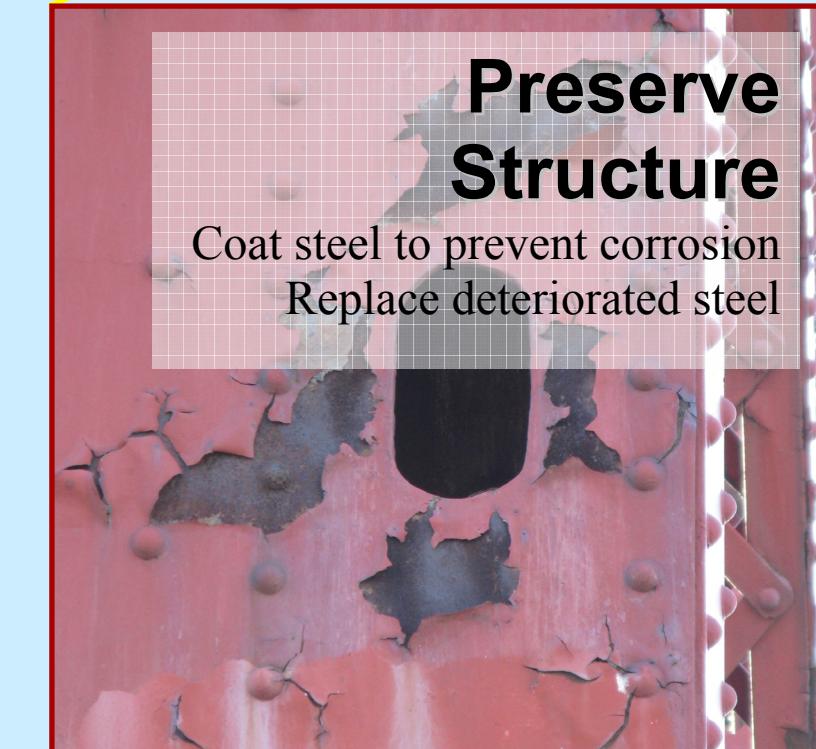
Preserve Structure

Coat steel to prevent corrosion
Replace deteriorated steel
