Multnomah County Courthouse Renovation Study

Volume 2
Final Report
Appendix
APRIL 13 2011

APPENDIX 1
HISTORIC STATUS PRESENTATION

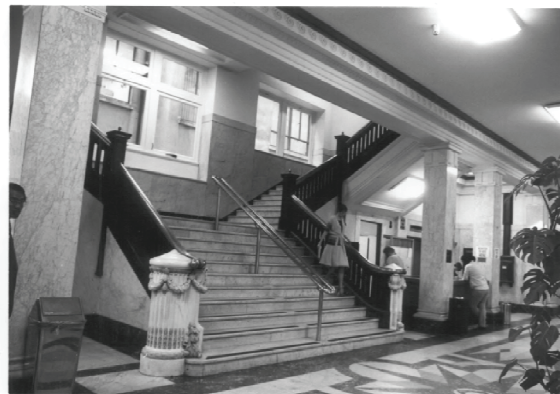
“The main staircase is open on all six floors; its marble steps and bronze railing make it the focal point of the structure.”

The original Courthouse interior was predominately of marble wainscoting, floors, and stairs; plaster walls, ceilings, and cornices; oak doors and molding; bronze stair railings and posts; and Italian statuary newel posts. Courtrooms were two-story spaces, decorated with marble Corinthian columns and tapestry-covered walls. The main staircase is open on all six floors; its marble steps and bronze railing make it the focal point of the structure.

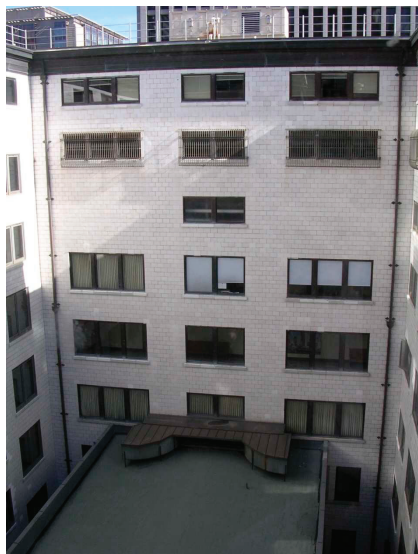
“The central courtyard, 64 by 100 feet, contains a three story annex completed in 1951.”
